Moose Creek Flat River Access Improvement Implementation Report

Phase 1 Construction
Phase 2 Streambank Bioengineering

MOOSE CREEK FLAT RIVER ACCESS IMPROVEMENT IMPLEMENTATION REPORT

*by*Jeff Dunn, Watershed Hydrologist

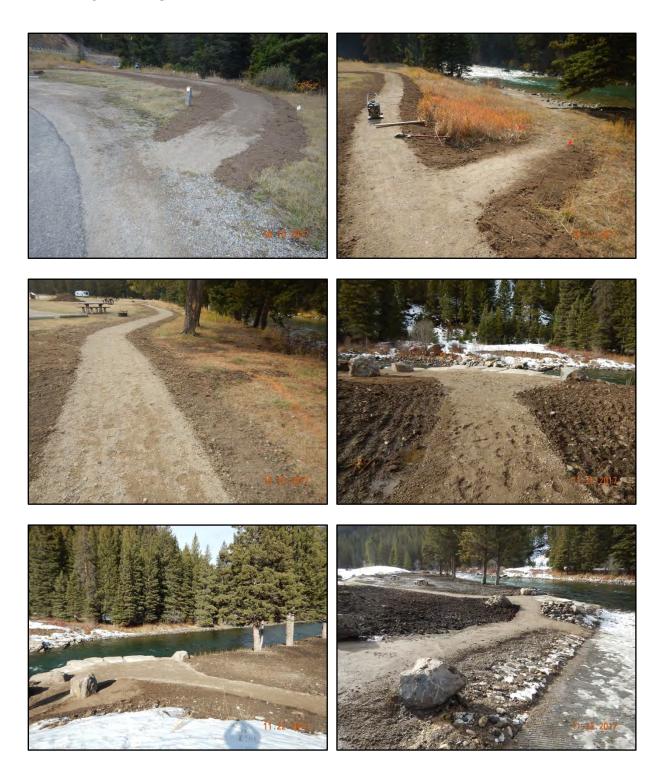
TRAIL INSTALLATION

Four sections of trail were completed totaling approximately 1,120 feet, including approximately 790 feet of elevated trail through the campground, approximately 80 feet of reconstructed trail leading from the parking lot to the rock terrace, and approximately 250 feet of trail connecting the parking lot to the kayak launch and the boat ramp. The contractor intends to perform touch-up work on the trail in the spring of 2018.
